Subject:
Proposed Plainwell No. 2 Dam Area Soil Sampling Locations

Plainwell No. 2 Dam History

Historical Inundation Area Delineation

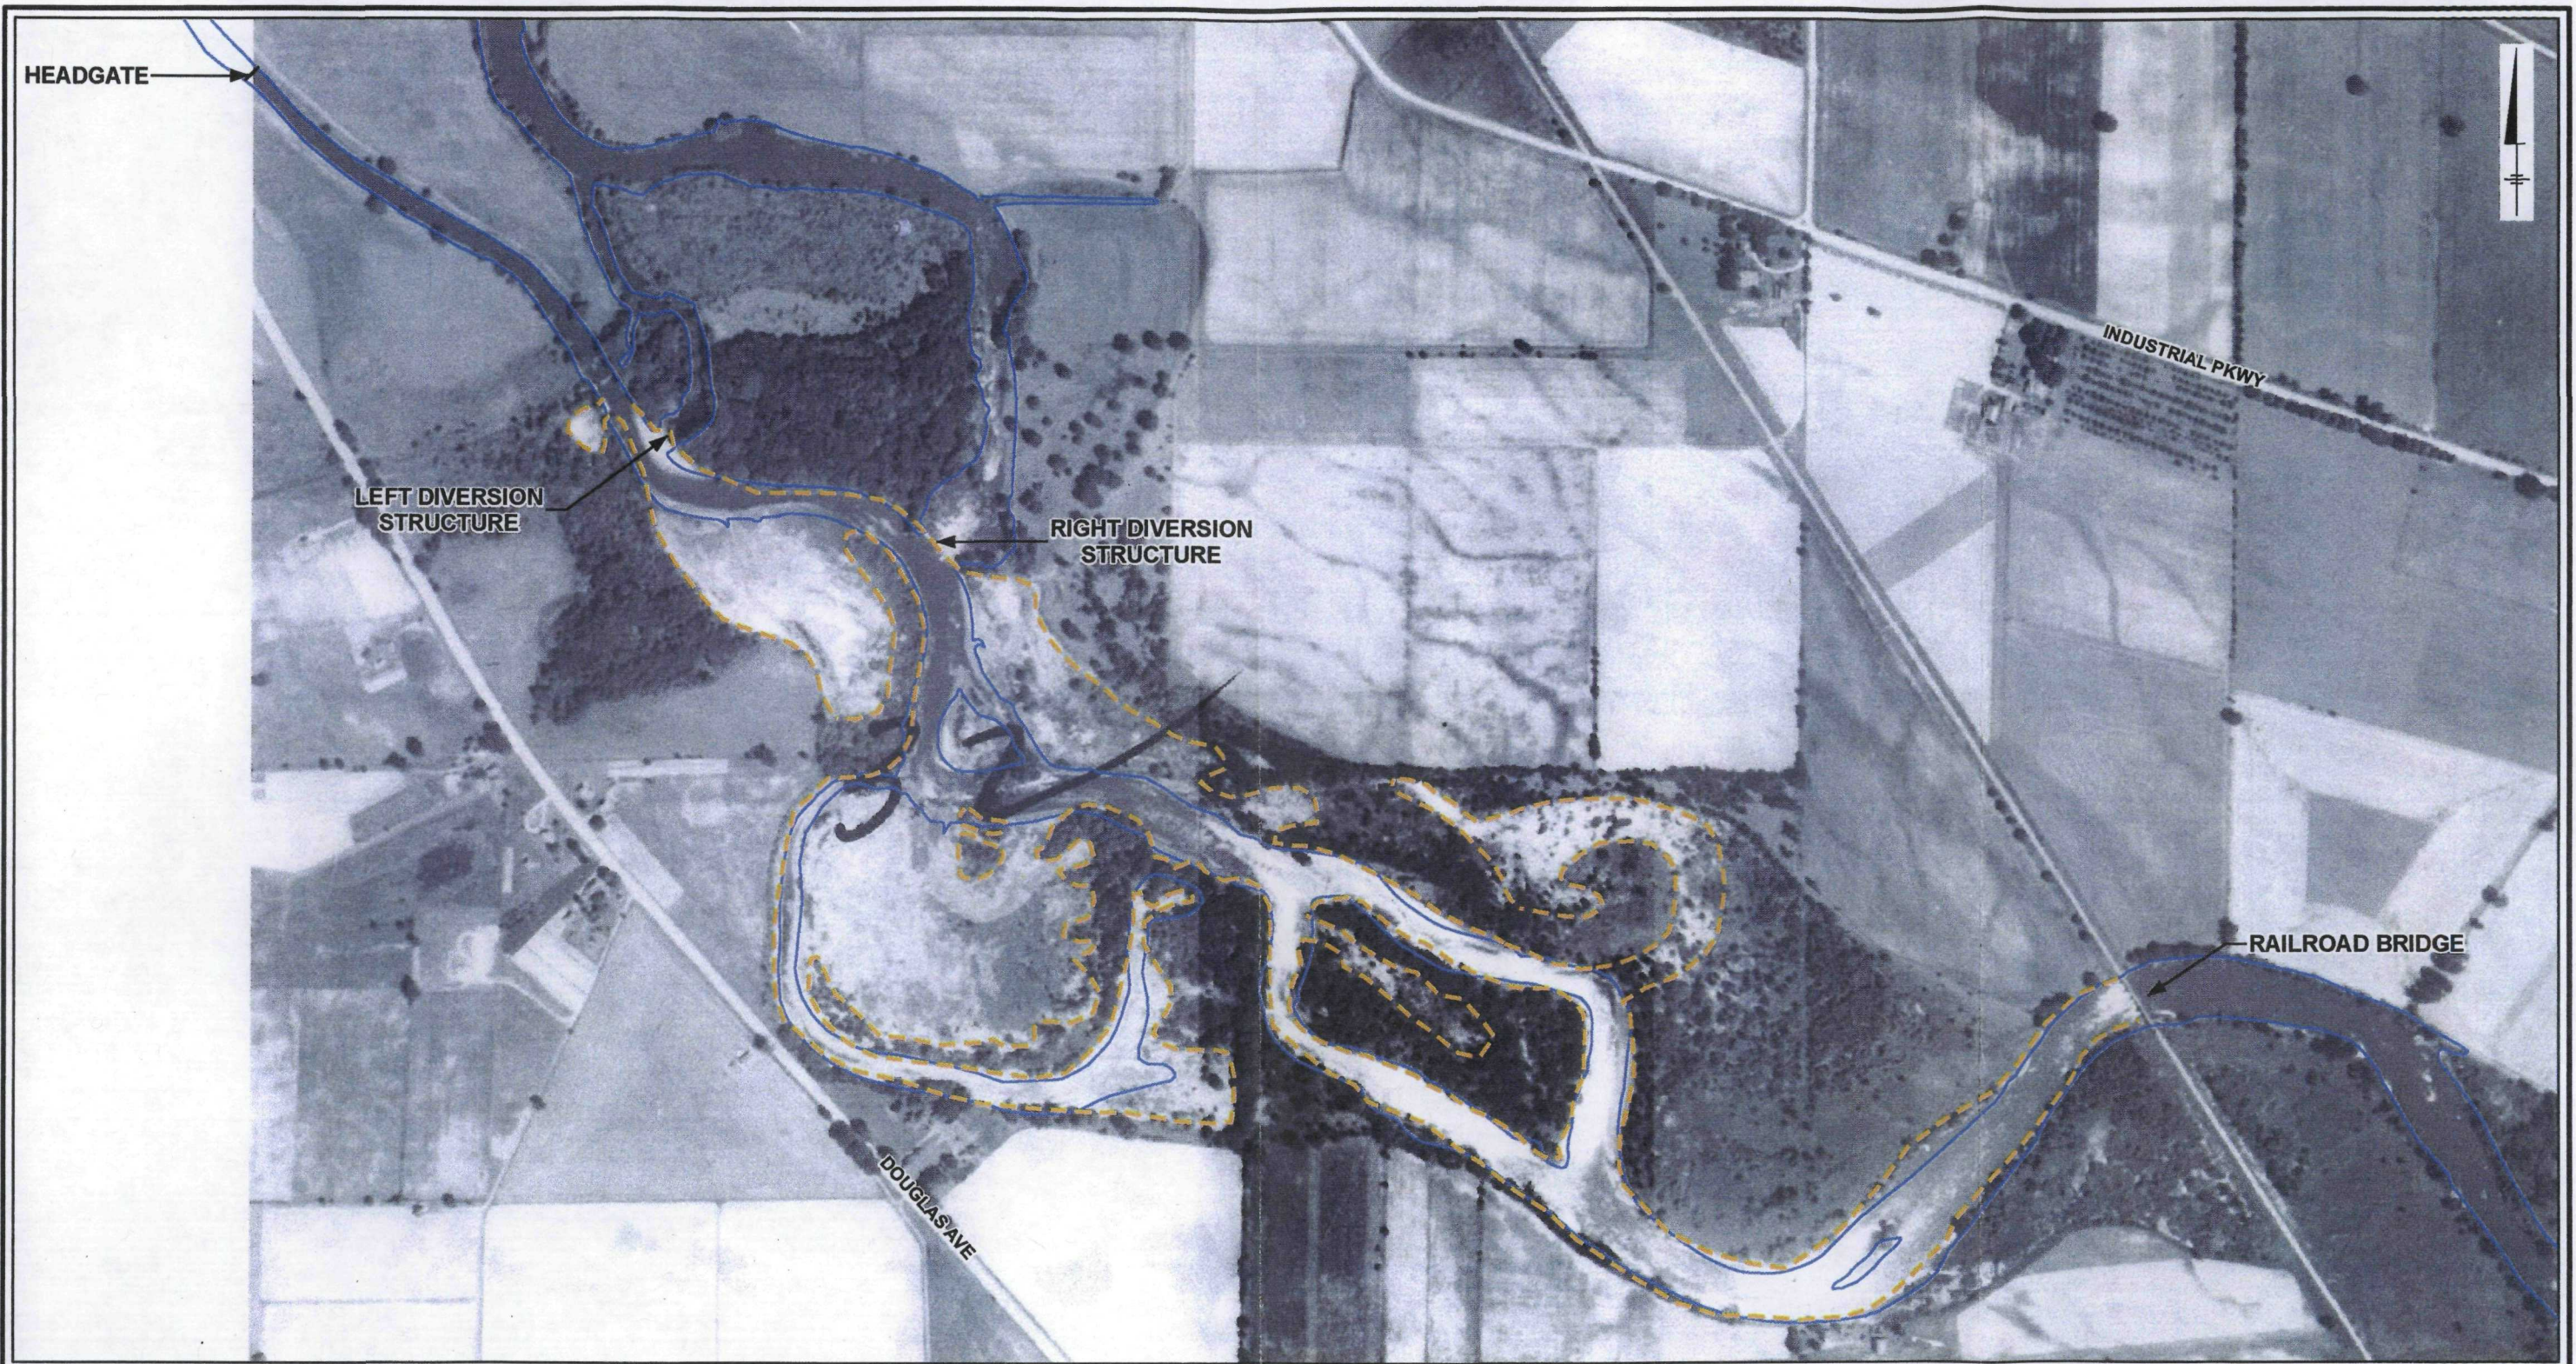
FIGURE
1

APPROXIMATE AREA OF INUNDATION
1938 AERIAL PHOTO

Aerial photos of the area from 1938, 1950, 1960, 1967, 1974, 1981, 1992, and 1999 were obtained from Environmental Data Resources, Inc. (EDR) in Milford, Connecticut. Upon inspection, the earlier photos show greater areas of inundation when compared to more recent photos. An initial delineation was prepared using the 1938 photo, where the extent of inundation was based on the presence of surface water and colorations or surface features that may indicate periodic flooding and deposition (Figure 1). Figure 1 is overlain on the 1999 aerial photo in Figure 2 to illustrate the apparently smaller area occupied by the river in recent times since removal of the dam structures lowered the pool elevation.

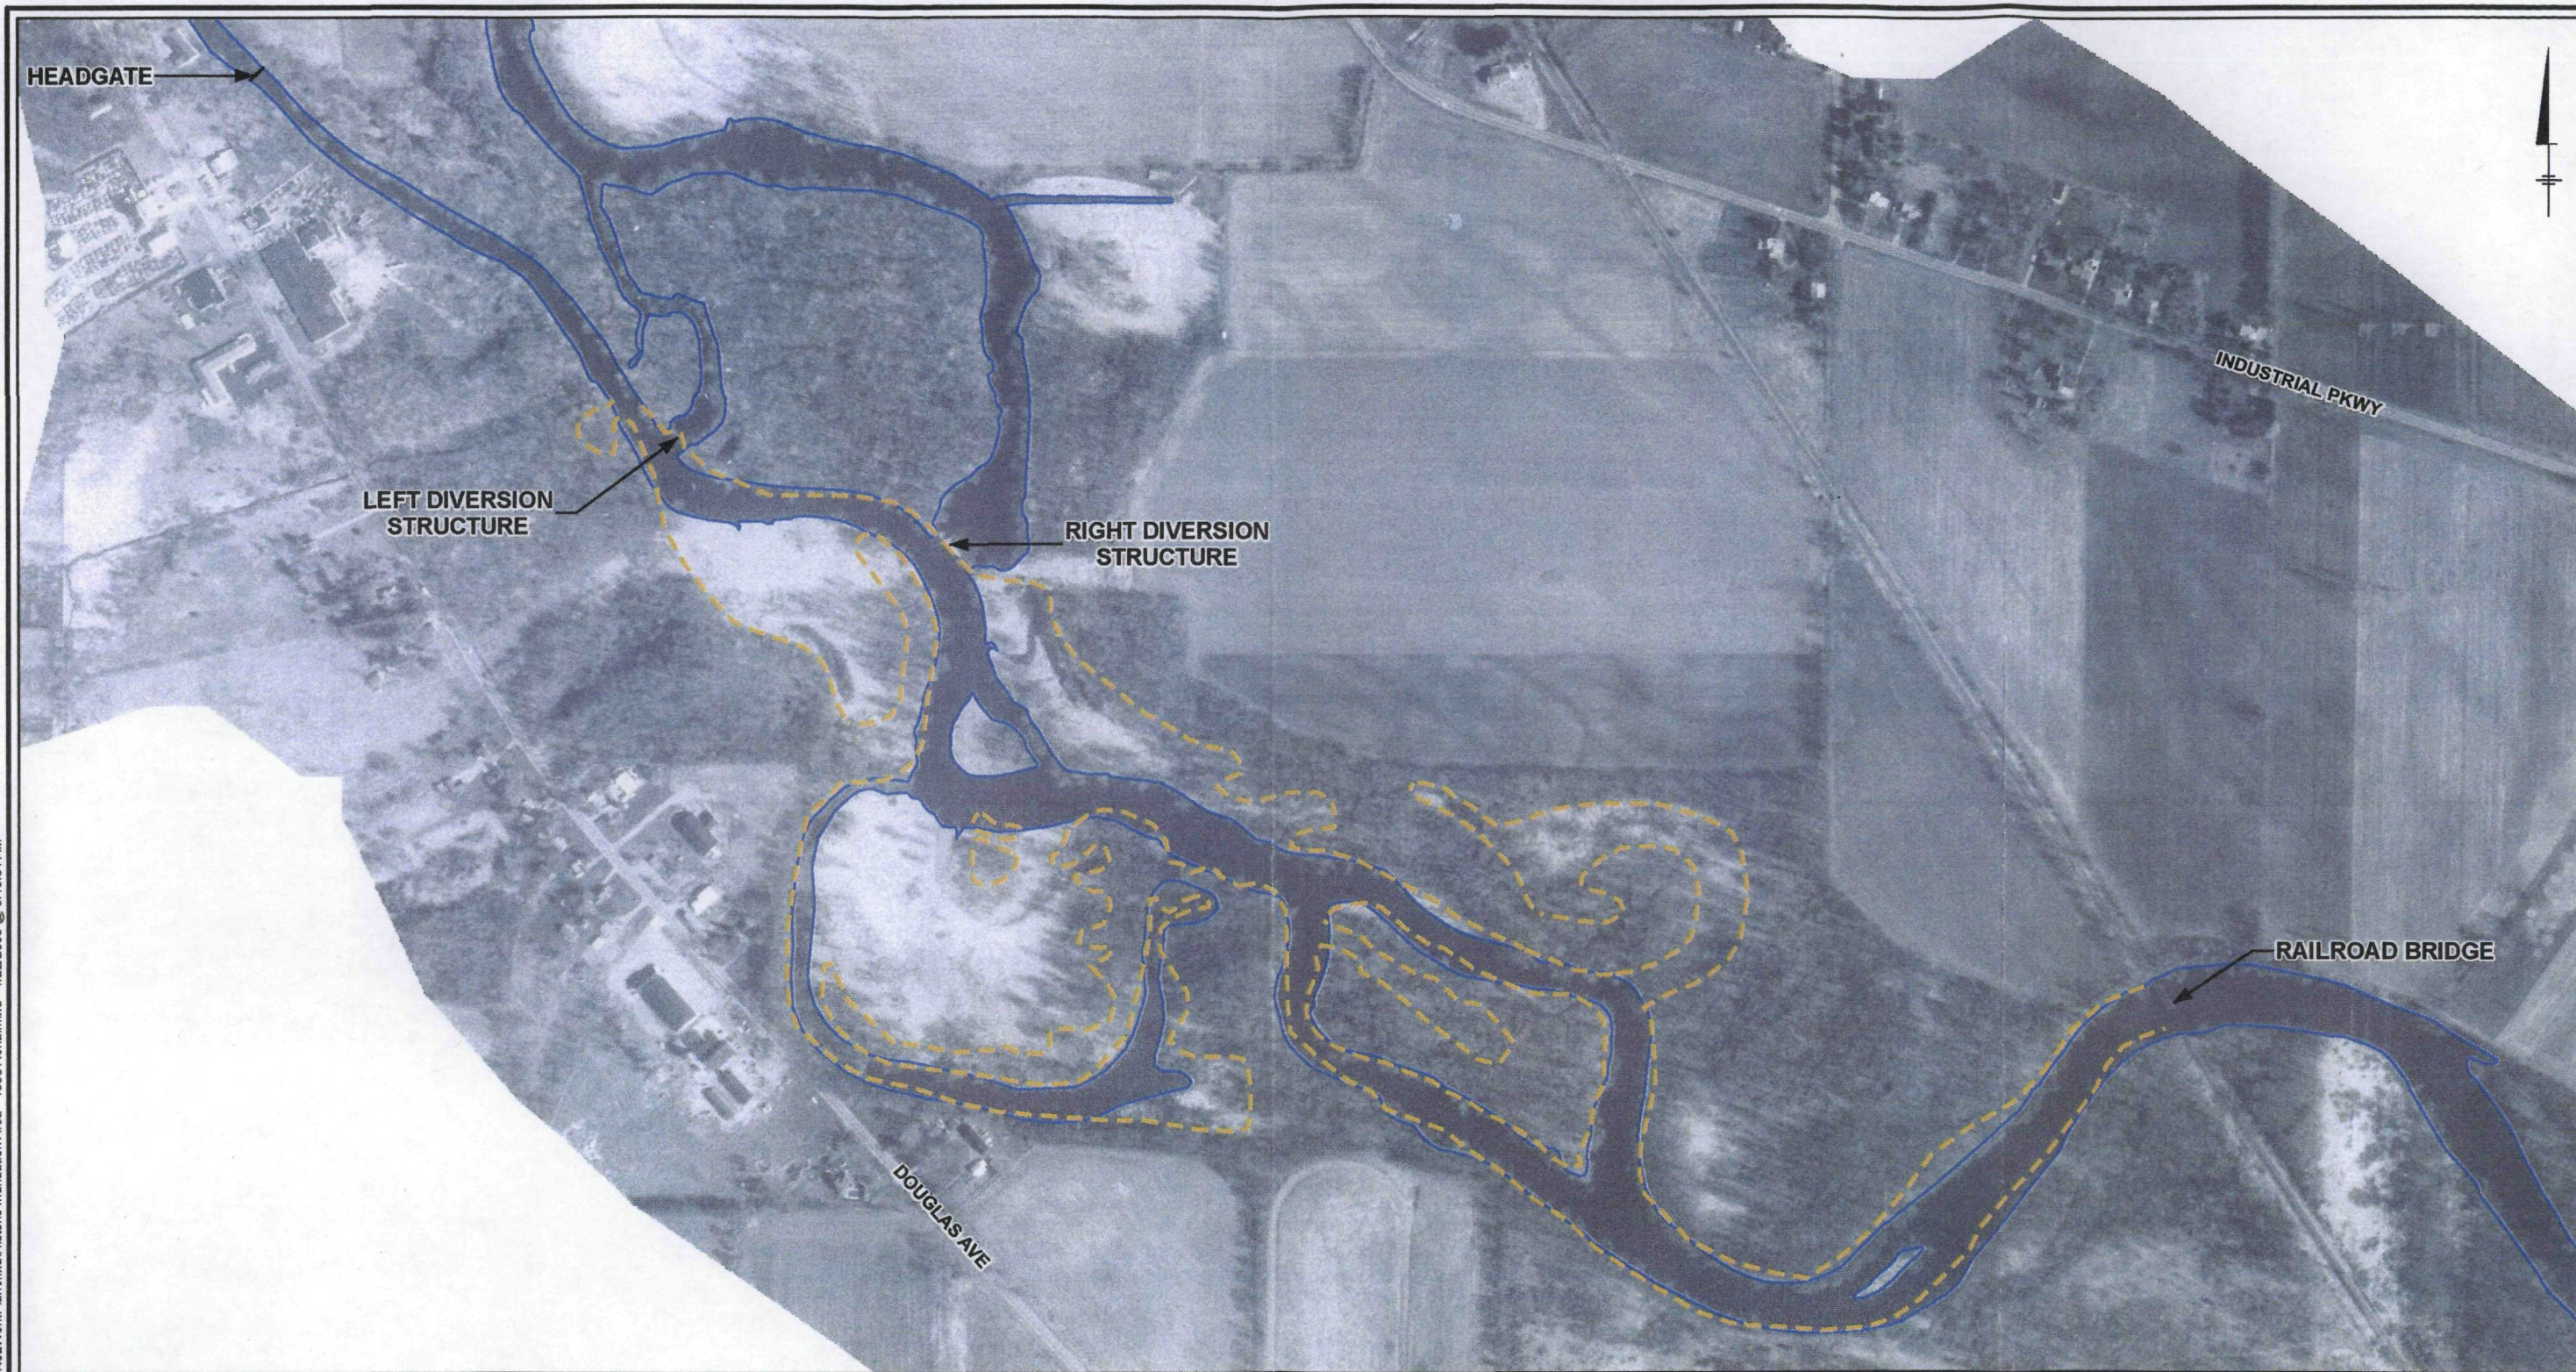
FIGURE
2

APPROXIMATE AREA OF INUNDATION
1999 vs. 1938 AERIAL PHOTOS

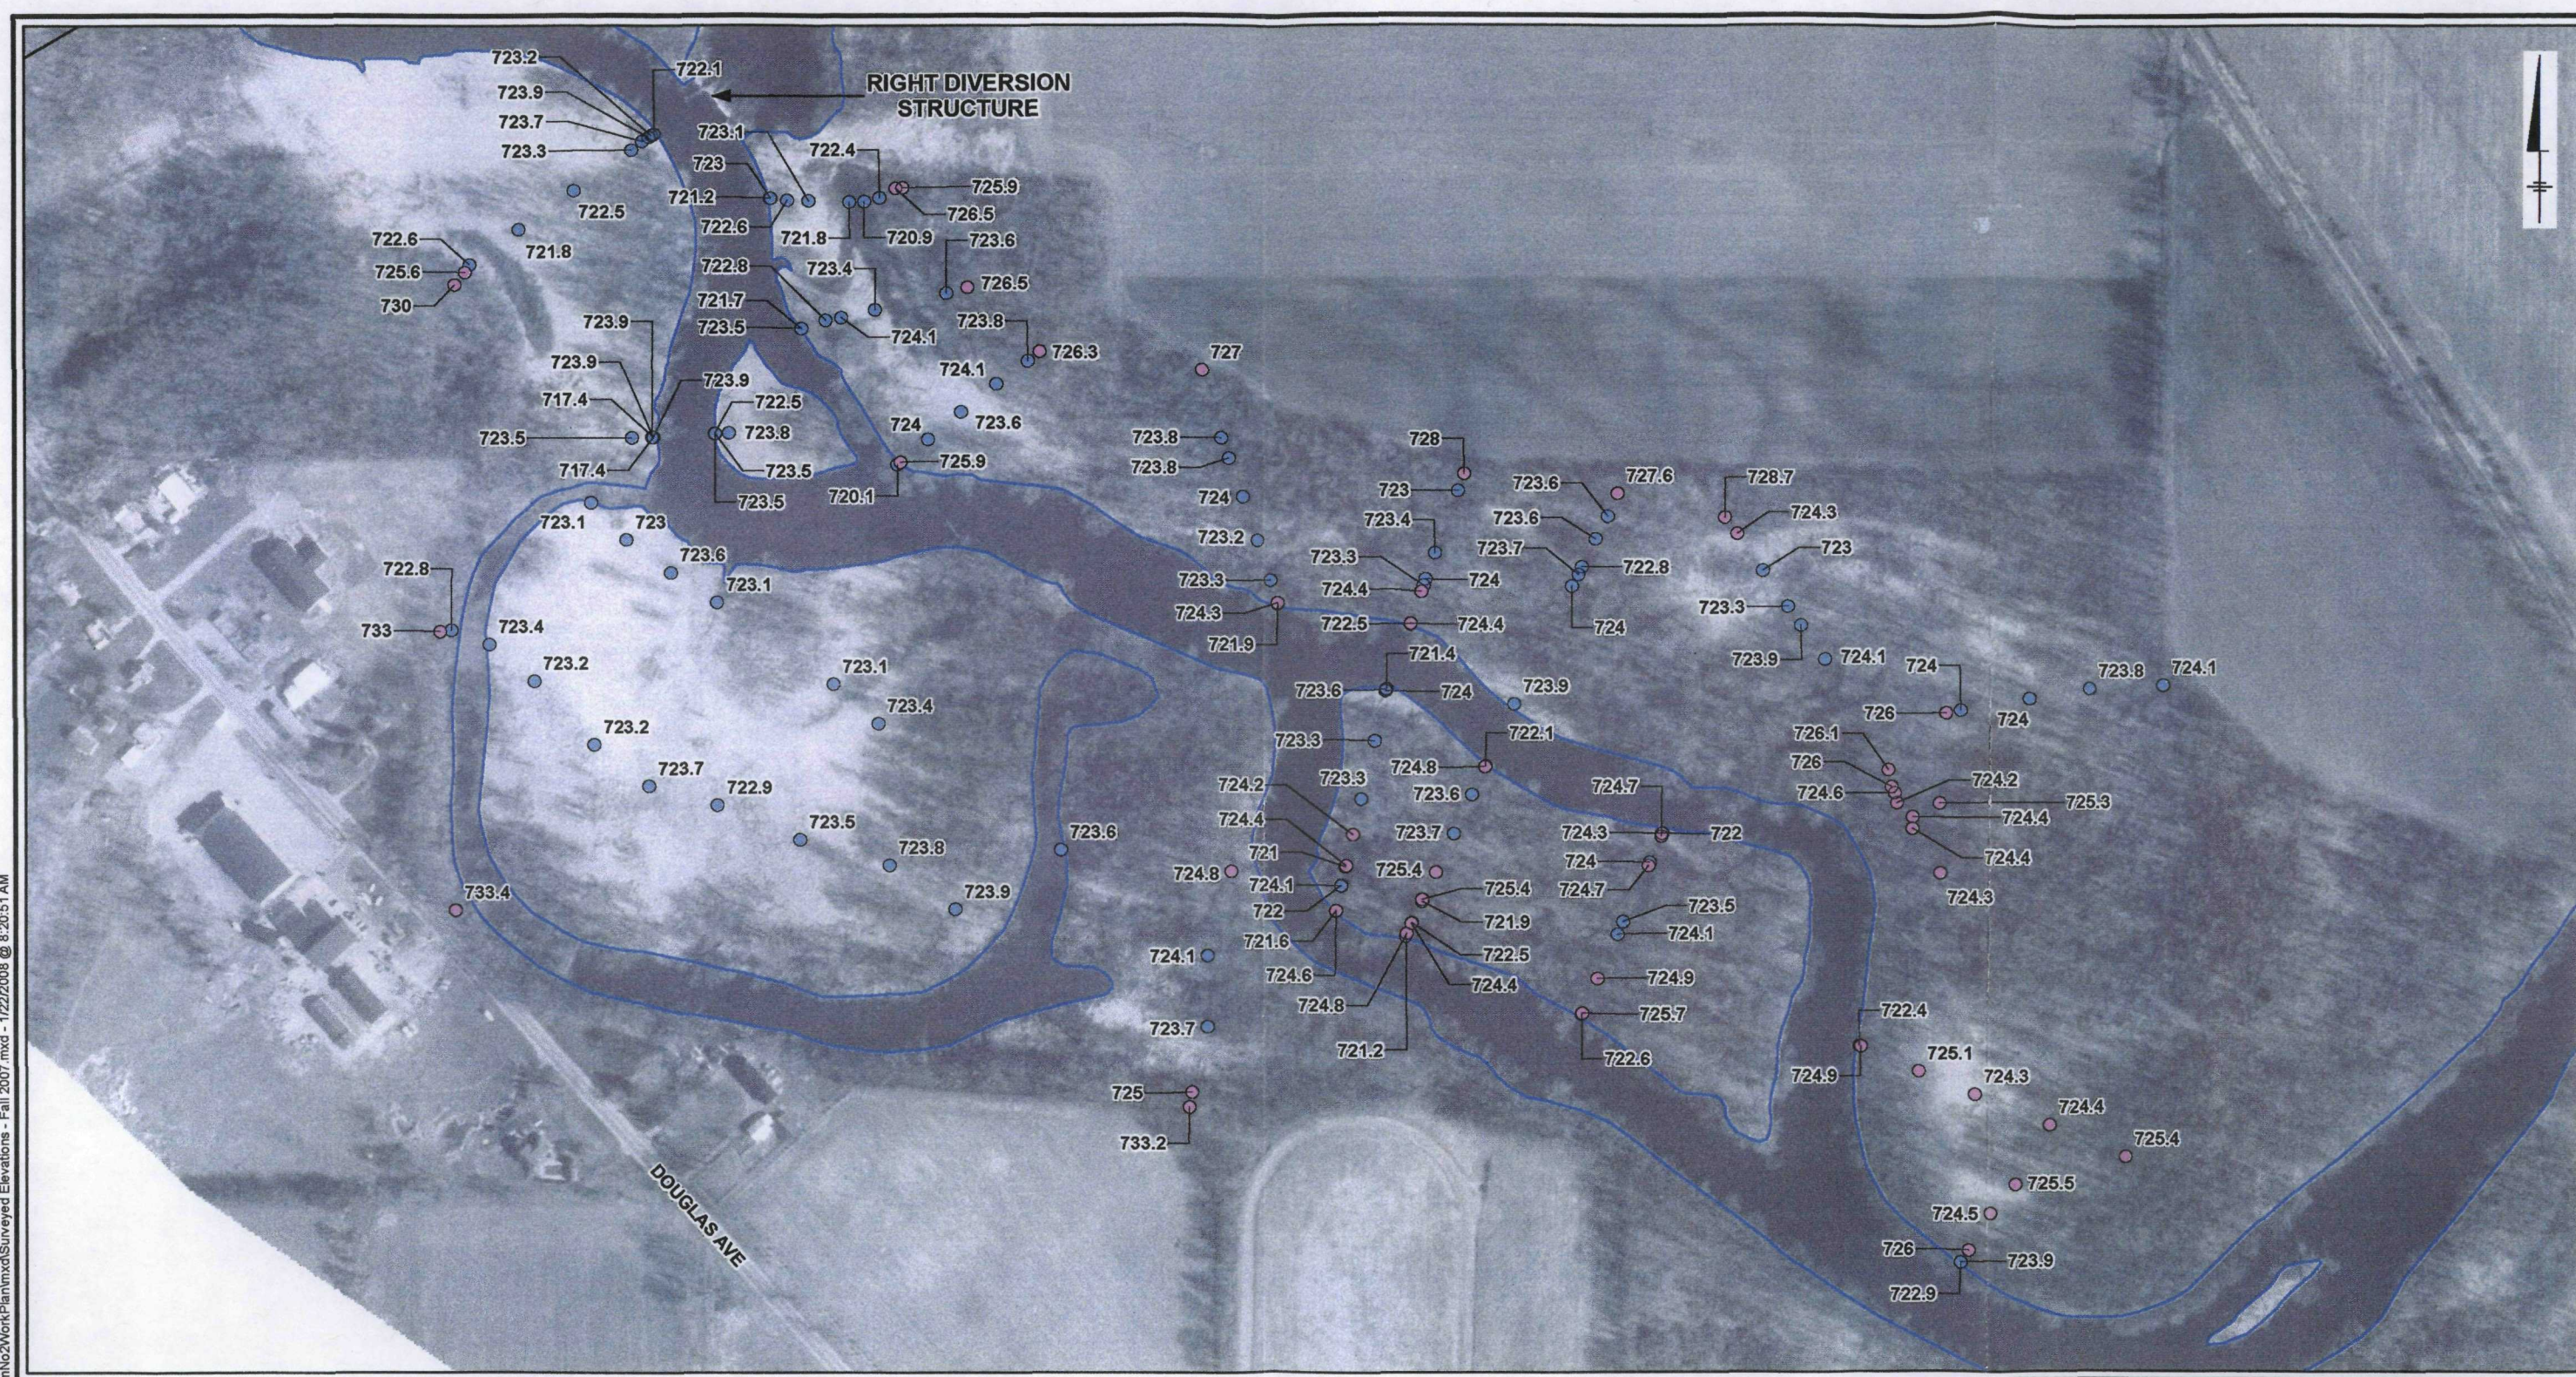
FIGURE
3

FALL 2007 SURVEY RESULTS

The aerial photos provide useful information, but are only a snapshot of conditions upstream of the dam. During periods of higher flow an area larger than that shown in the aerial photos may have been flooded. Survey and reconnaissance of the area was performed in October and November 2007 to provide additional information on floodplain boundaries. Elevations were also surveyed along transects (Figure 3), and around the right and left diversion structures (Figures 4 and 5, respectively) in fall 2007. Surveyed ground elevations and field observations indicate the floodplain is relatively flat and lack distinct banks in a number of areas. Evidence of high water was observed, suggesting a larger area than that delineated based on the 1938 air photo was occasionally flooded. The outer edge of the river valley is discernible as a distinct change in slope; however, the valley limits appear to be located well beyond the normal floodplain in some areas.

The Dam Inspection Report (USACE, 1979) lists the normal pool elevation as 720 feet above MSL and the maximum pool elevation as 722.2 feet above MSL (NGVD 1929). These pool elevations would largely be confined to the existing channel (i.e. within the 1999 shoreline); however, a discrepancy of approximately 2 feet was observed between surveyed elevations of the water control structure surfaces and corresponding elevations cited in the 1979 dam inspection report. Elevations at points reported in the Dam Inspection Report were surveyed in fall 2007 to be approximately 2.0 feet higher than the elevations reported. For example, the top of the sill of the right diversion structure was reported as 719.5 feet in the Dam Inspection Report, and the adjacent embankment elevation was given as 725.5 feet. Recent survey data show the elevation of the sill of the right diversion structure to be 721.6 feet, whereas the adjacent embankment elevation is 726.3 feet. Survey elevations of the right and left diversion structures are presented in Figures 4 and 5, respectively. During development of survey information for design of the Plainwell Time-Critical Removal Action currently underway, a similar discrepancy was noted with respect to reported elevations for the Plainwell Dam. At that time, the USGS benchmarks were independently resurveyed by a third party to confirm their elevations, from which it was concluded that the older reported elevations for the Plainwell Dam were incorrect. It is suspected that the elevations in the Dam Inspection Report (USACE 1979) for the Plainwell No. 2 Dam are also incorrect.

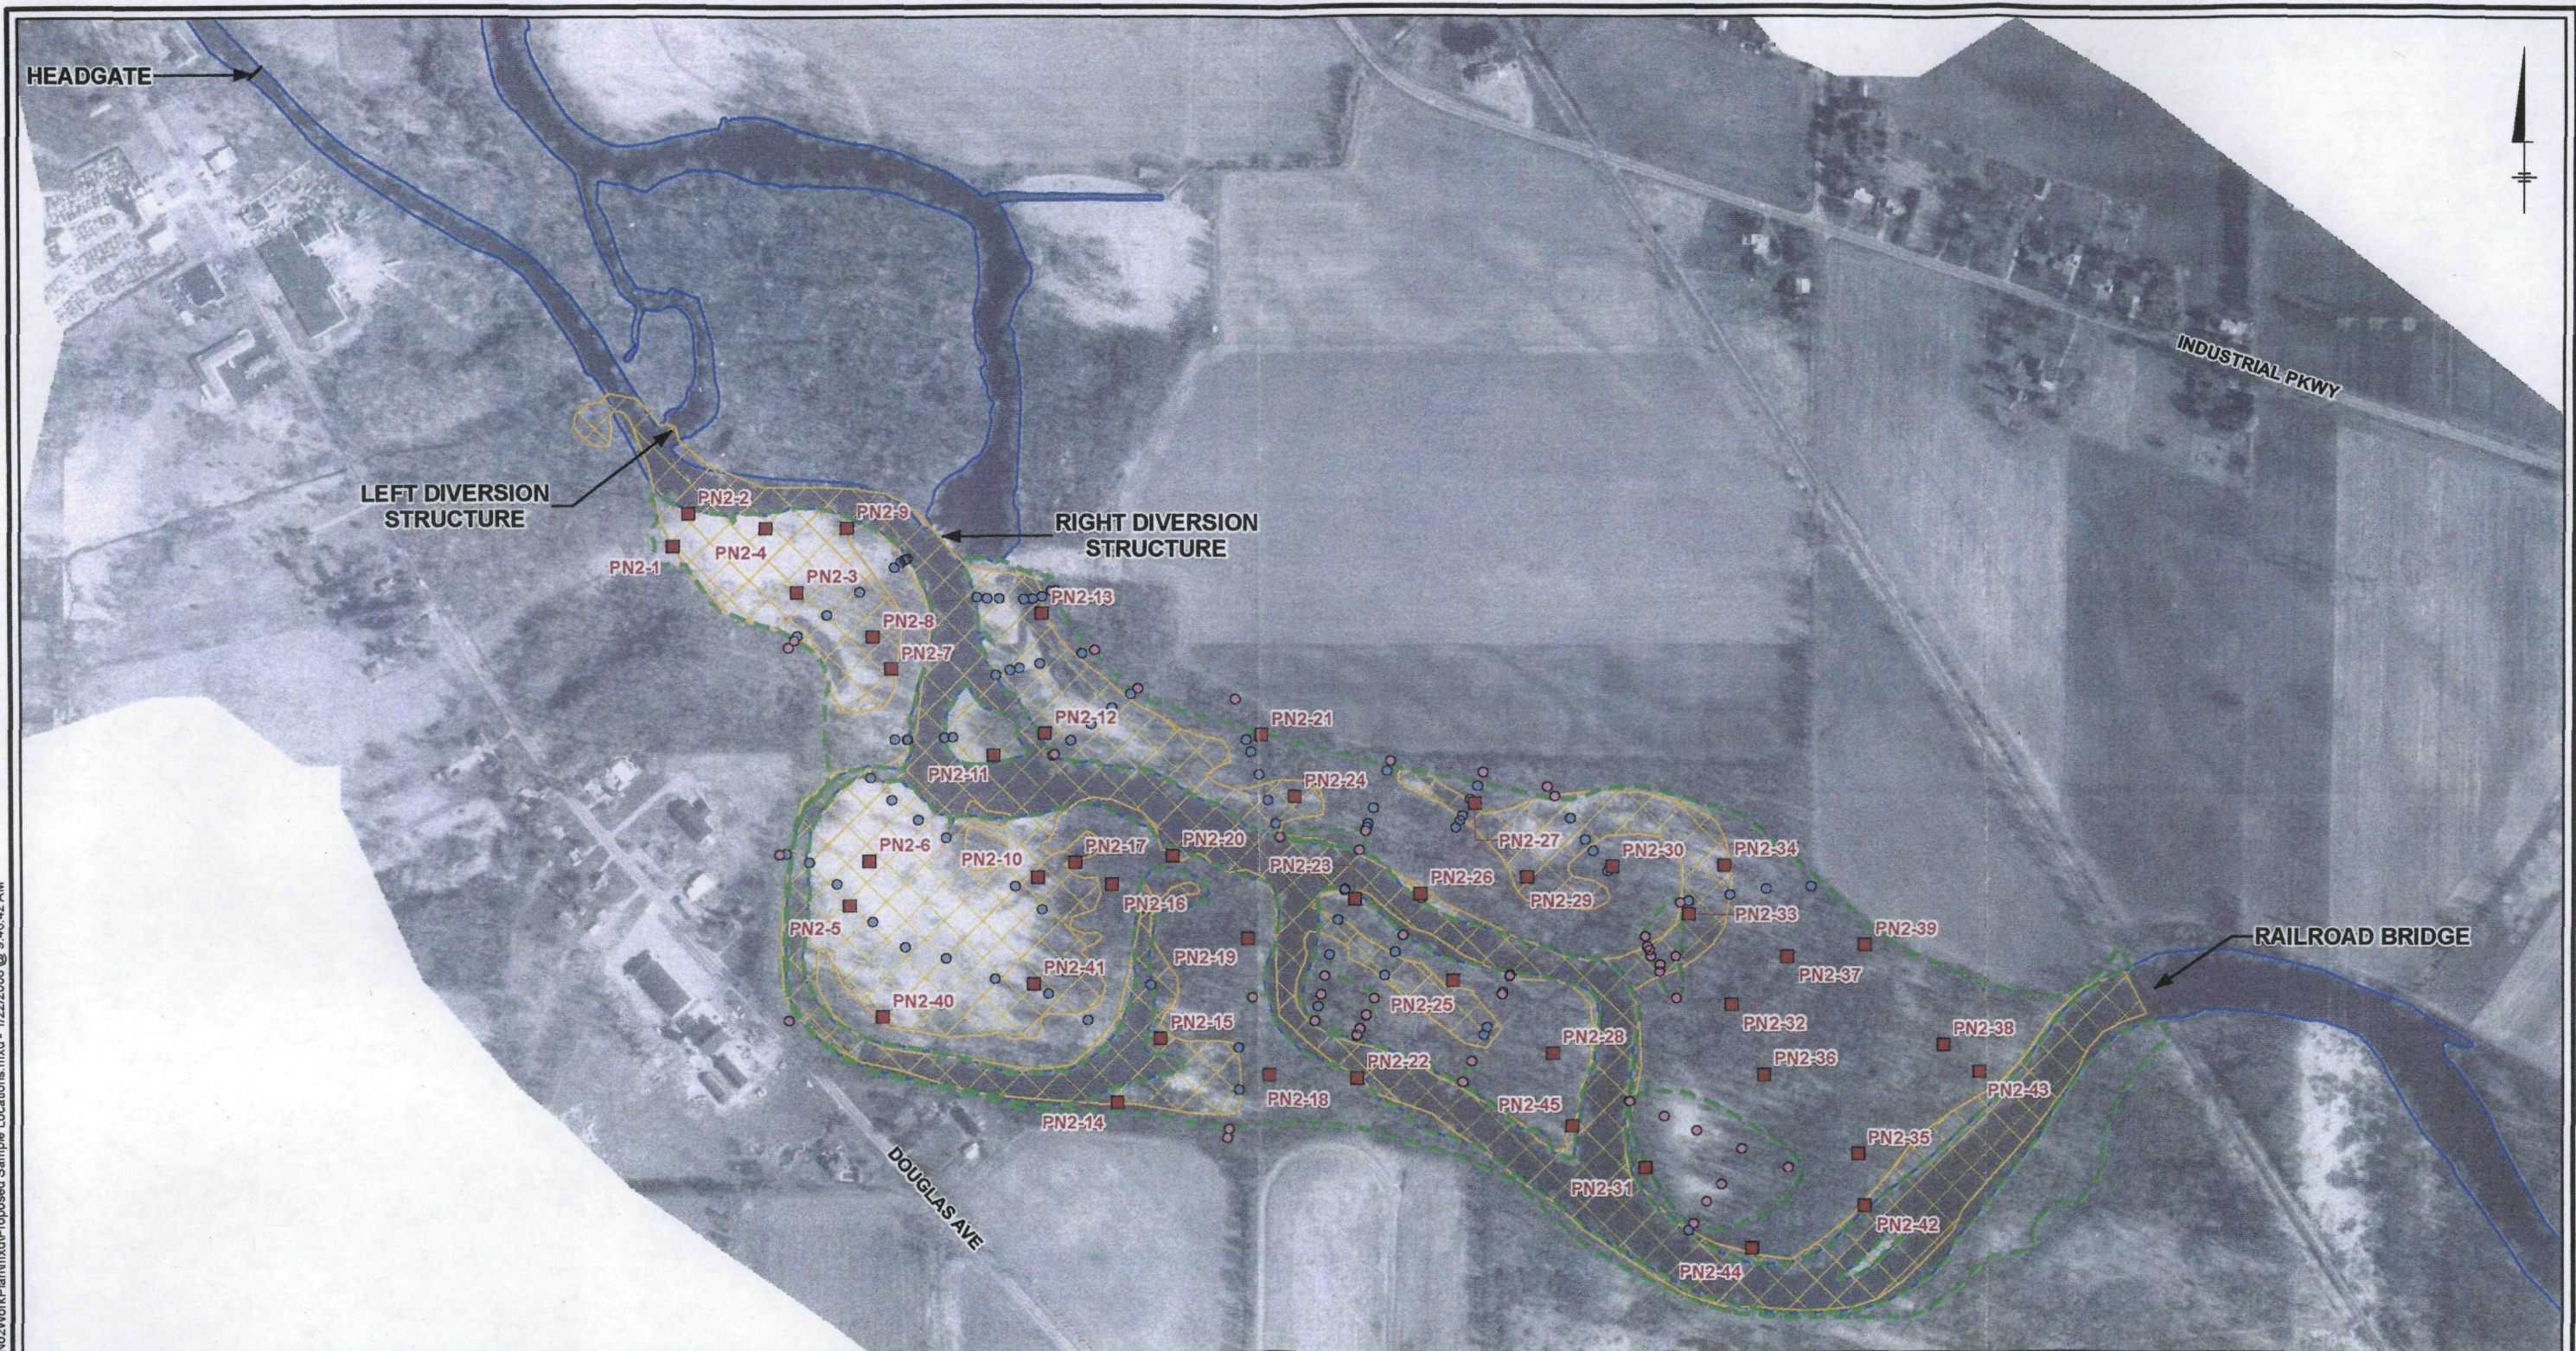
- PROPOSED SAMPLE LOCATION
- FALL 2007 SURVEY LOCATIONS:
 - BELOW MAXIMUM POOL ELEVATION (< 724.2)
 - ABOVE MAXIMUM POOL ELEVATION (> 724.2)
- 1938 IMPOUNDED AREA (APPROXIMATE)
- ESTIMATED CONTOUR OF MAXIMUM POOL ELEVATION (724.2 feet)
- SHORELINE

Proposed Sample Locations
